# Manhole Inspection Summary

Manhole # S41C\_\_044MH

Insp Date: **11/26/08 1:30 PM**

**Location** Address: **1210 comet muse**

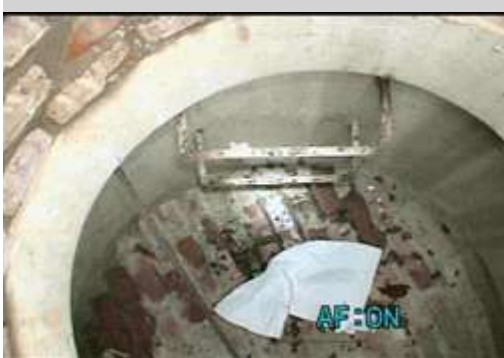
Defect 1

Count: **2** Missing: **0** ☒ **Corroded**

corr steps

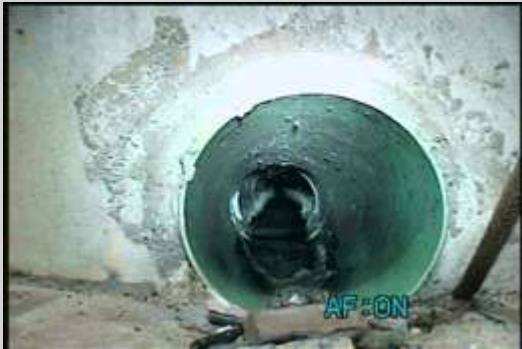
12 O'Clock Outflow

8 in. Circular Gravity Sewer  
Pipe Out @ 12 O'Clock
